Analysis of Lighting Fixtures

MMR Project No. 82999

MassDOT
Boston, MA

April 5, 2011

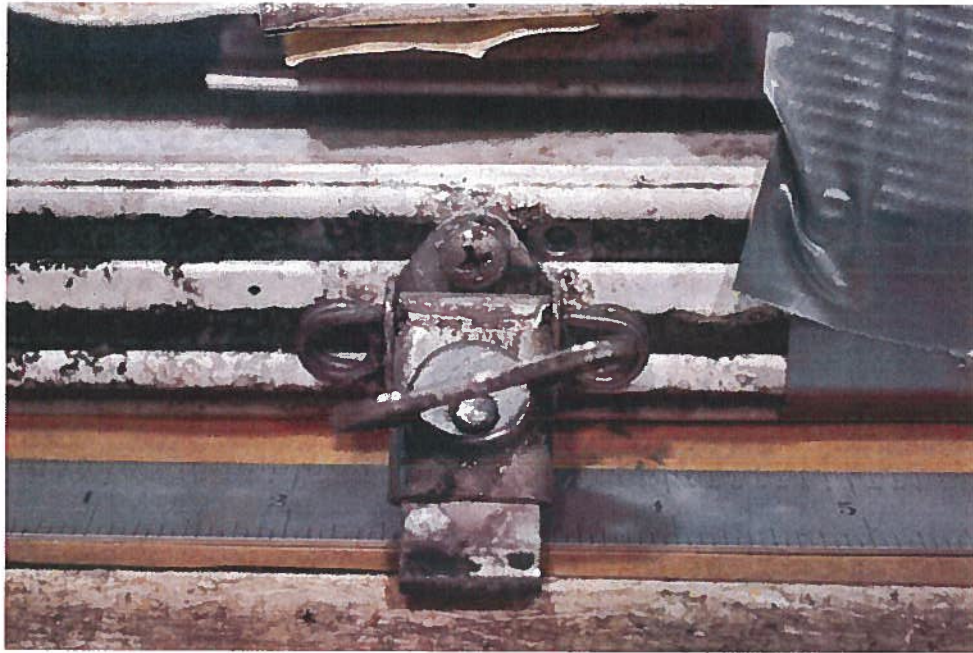
Figure 13: A typical clip from the incident base.

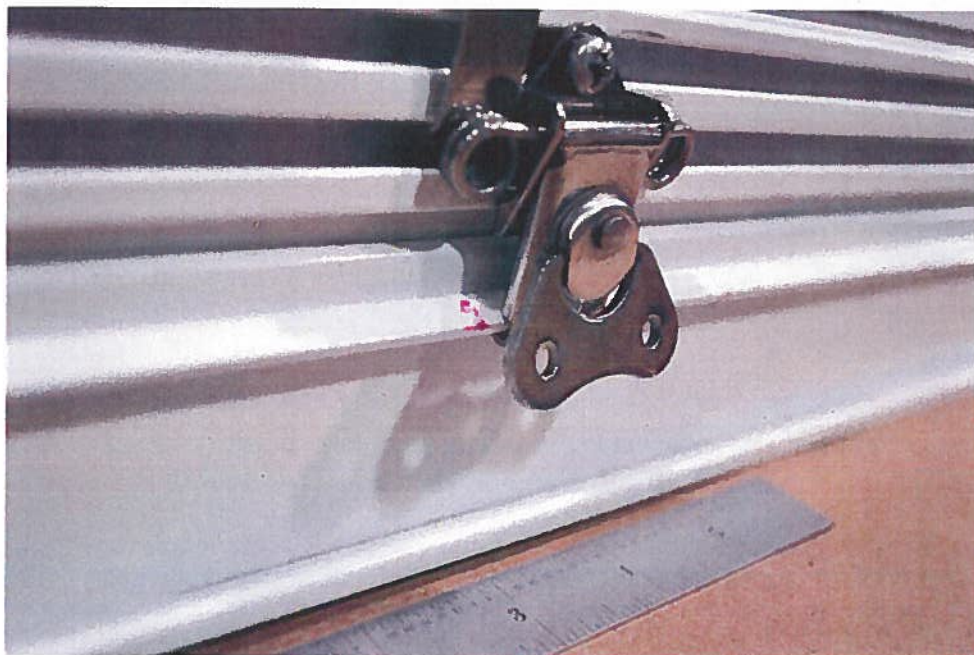
Figure 81: Sample #2 (NuArt): The same as in Figure 80 at an angled view showing attachment of a clip to the wireway lip.

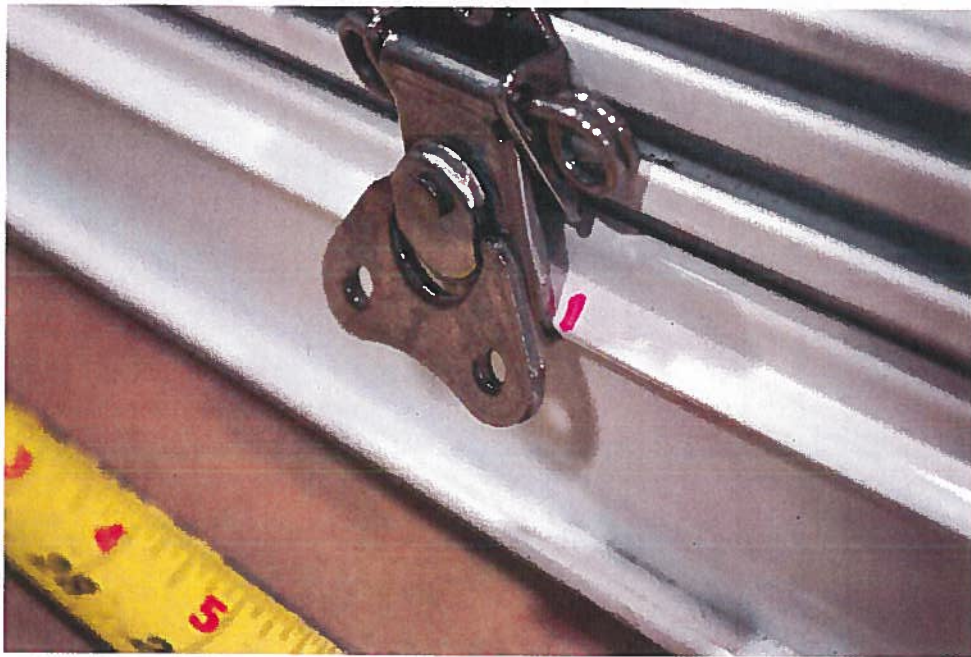
Figure 86: Sample #3 (Schreader): The same as in Figure 85 viewed from an angle to show the clip attachment to the lip area of the wireway.
